# America's Courthouse: the History and Restoration of the Dome of the Old Nassau County Courthouse

Nancy A. Rankin

*AIA, LEED AP, John G. Waite Associates, Architects PLLC, USA  
E-mail: NRankin@JGWAarchitects.com*

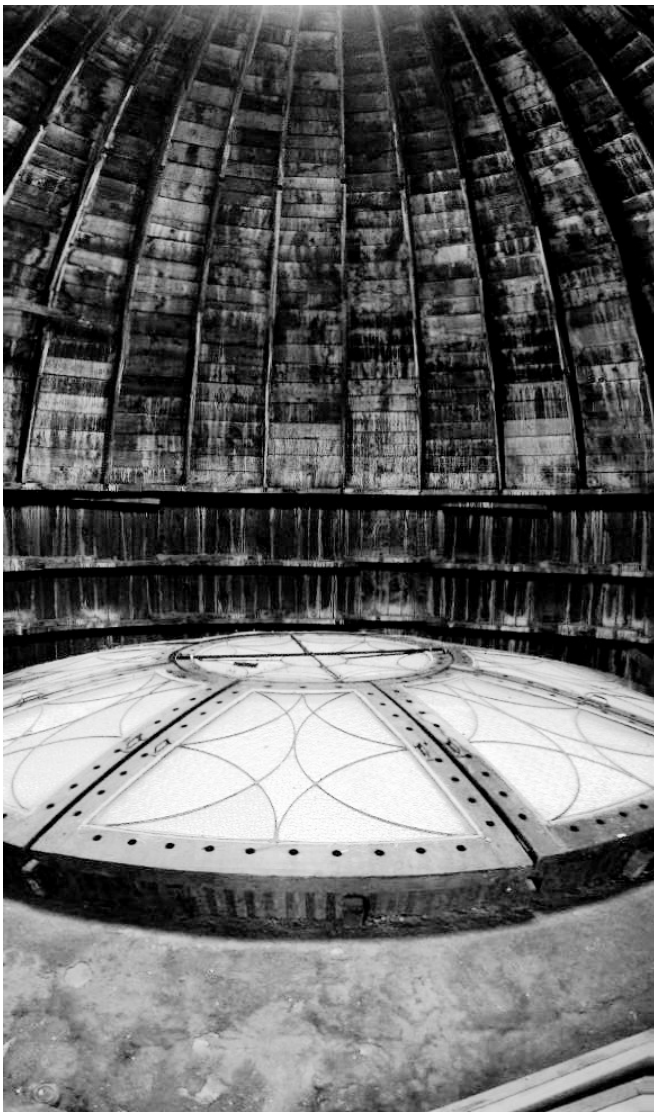
*Fig. 4. Existing conditions of the space between the double dome, with original wood board formwork remaining in place at the interior surface of the outer dome. The segmented Rotunda laylight at the oculus of the inner dome is in the foreground. Photo courtesy of JGWA.*

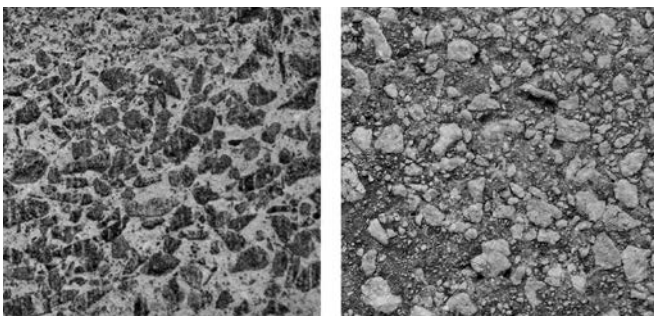
The original mix included a significant amount of "rock flour", indicating that the aggregate was not as thoroughly washed as it would be today. In addition, the cement content of the mix was very low, and the water-cement ratio was determined to be higher than what is commonly specified today. It is not clear what measurable effect the rock flour, the limited quantity of cementitious materials, and the higher water-cement ratio may have had on the structural performance of the concrete mix.

The testing of the core samples also confirmed that the white concrete mix for the dome had included a significant amount of crushed glass, an unusual additive that would have contributed a distinctive "sparkle" to the original exterior surface of the dome. This had been documented in the county's archival records, but was no longer apparent on the existing bronze-coated surface of the dome.

*Fig. 5. Detailed photographs illustrating the two different types of aggregate (trap rock and marble) used within the same cement binder to provide aesthetic character to the exterior walls and trim of the reinforced-concrete structure. The dome material was similar to the sample at right, but with a finer marble aggregate, rock flour, and crushed glass that provided a smoother, uniform finish with sparkle. Photo courtesy of JGWA.*

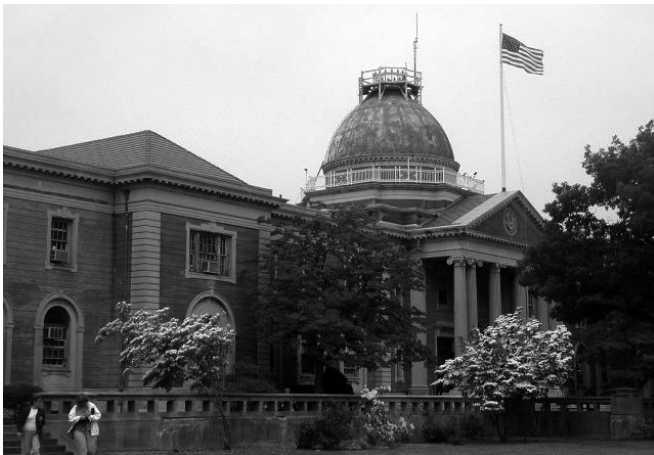
Fig. 6. Front façade of the Old Nassau County Courthouse in 2002, with bronze coating applied to dome. Photo courtesy of JGWA.

The pervasive cracking condition was more visually apparent when the bronze coating applied in the 1970s was removed from the exterior surface of the outer dome: this was accomplished using an environmentally safe paste-consistency coating remover that did not contain methylene chloride or methanol, followed by a low-pressure water cleaning with an angled fan-tip nozzle. This allowed an examination of the entire exterior outer dome surface so that specific concrete deterioration problems could be addressed during the dome's restoration.

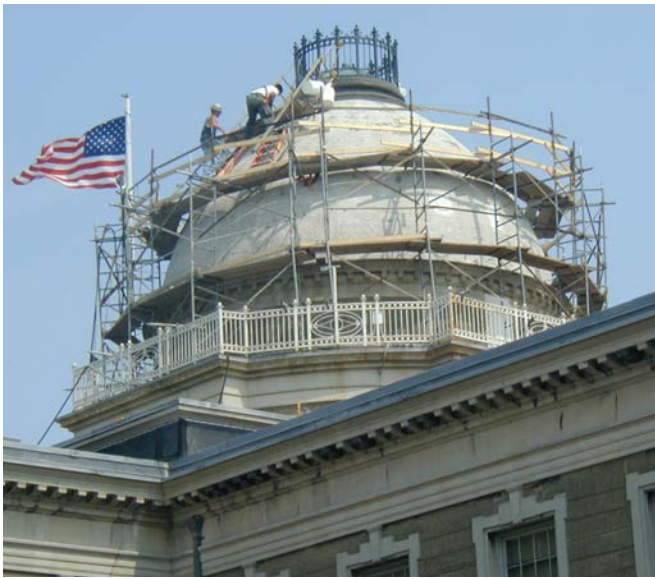
No control or expansion joints appear to have been provided within the original concrete construction of the dome or other structural elements of the building. Despite the inclusion of a very frequent and regular pattern of 1¼" diameter twisted steel rods within the thin 3" shell of the exterior dome structure, minor hairline cracking was observed on the original exterior surface of the outer dome.

Likely causes of the surface cracking condition are both seasonal and diurnal temperature changes, which create thermally-induced tensile and compressive stresses within the concrete that manifest in cracks through the thickness of the concrete. Despite the quantity and locations of these hairline cracks at the dome surface, almost no evidence of steel reinforcement corrosion, such as rust stain seepage or large areas of concrete spalling due to expanding oxide products of erosion, was observed.

*Fig. 7. Construction scaffolding surrounding the concrete dome of the Old Nassau County Courthouse, following removal of the non-original bronze coating and prior to concrete repairs. Repair mortar mock-up samples are visible on the right side of the dome, above the first stage of scaffolding. Photo courtesy of JGWA.*

Minor repairs to exposed reinforcement bars were required prior to any concrete surface repair procedures. Small lengths of deformed or severely corroded bars were cut out, and exposed steel reinforcement to remain was coated with two applications of an epoxy-modified, cementitious bonding and anticorrosion agent. Once inappropriate prior repairs had been removed and other areas of spalled concrete surface had been addressed and the entire exterior surface of the outer dome was sound and smooth, a water-based alkaline solution of corrosion-inhibiting chemicals that penetrate concrete by diffusion to form a protective barrier on unexposed steel reinforcement was applied.

Several larger cracks within the dome were routed out with hand-tools and repaired with structural repair mortar; similar work was also done at the upper and lower profiled cornices, which had a rough aggregate surface that was replicated by pressing matching aggregate into the still-damp surface of the crack repair mortar. Prior to the resurfacing of the dome, an epoxy bonding agent was applied over the entire repaired concrete surface. While the bonding agent remained tacky, the job-mixed custom patching repair mortar matching the original concrete mix in composition, texture, and color was troweled over the exterior surface of the outer dome and worked into a smooth polished finish. The dome surface was then wet-cured for 7 days using damp burlap.

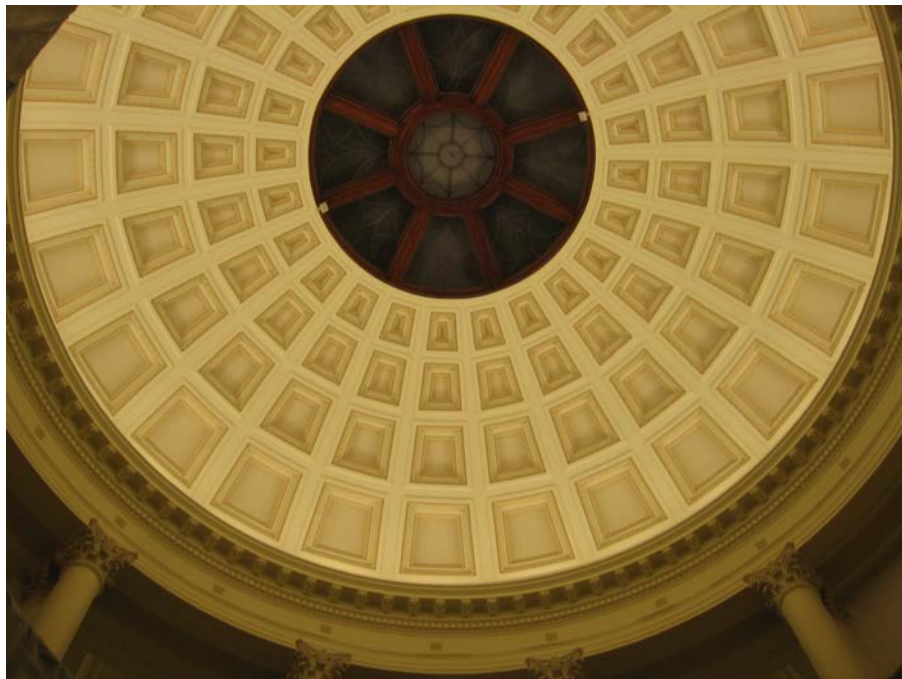
*Fig. 8. Interior view of the Rotunda looking up at the restored segmented zinc-camed decorative glass laylight at the oculus of the inner dome. The original decorative paint scheme highlights the restored plaster coffered ceiling. Photo courtesy of JGWA.*

Within the Rotunda, the plaster-and-canvas coffered ceiling suspended below the concrete frame of the inner dome was restored. Again, paint analysis of the original colors enabled the restoration of the original decorative paint scheme of the interior of the space, and the original gold-leaf two-arm bracket light fixtures around the base of the inner dome were restored, re-wired, and reinstalled. In later phases of the building's restoration, the entire Rotunda including the ceremonial staircases, the terrazzo floor finishes, and the four Works Progress Administration murals were also restored.
