# America's Courthouse: the History and Restoration of the Dome of the Old Nassau County Courthouse

Nancy A. Rankin

*AIA, LEED AP, John G. Waite Associates, Architects PLLC, USA  
E-mail: NRankin@JGWAarchitects.com*

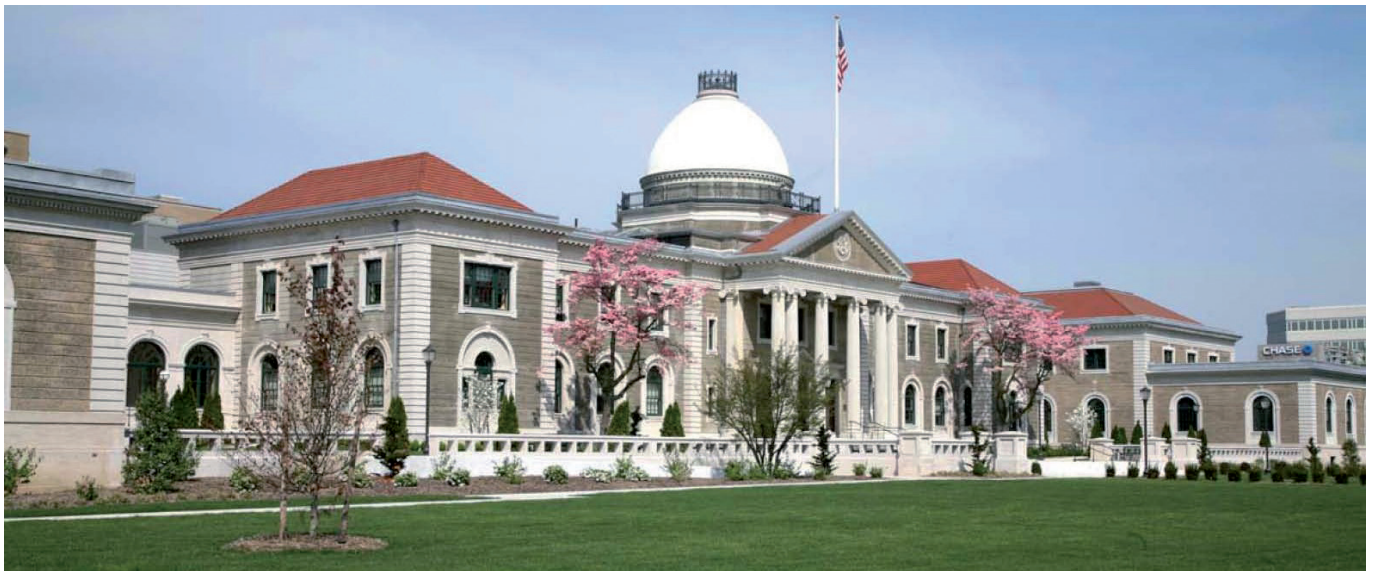
Fig. 9. The front façade of the Old Nassau County Courthouse, following a comprehensive rehabilitation of the entire building that began with the restoration of the central dome. Photo courtesy of JGWA.

stripped to bare metal, repaired and welded where required, and repainted. Paint seriation of the existing coatings was undertaken beforehand to determine the original colors of the first layers of paint, which were matched and used on the finished railings.

The exterior oculus at the top of the dome was reglazed using the original 1/2" thick glass lites and the original radial pyramid steel frame; the glass was removed, cleaned, and reset into the primed and painted frame. Corroded anchors cast into the top decorative concrete profile for both the oculus and the metal railing were also cleaned, primed, and repainted. The wood door and frame providing access to the space between the two domes from the roof was reproduced to match original details.
